## Final report

### Novacell

**Subject** : determination of resistance to root penetration

By order of Kimmenade Nederland B.V., BDA Keuringsinstituut B.V. has performed an investigation on the resistance to root penetration on a 'Novacell' liquid applied roof waterproofing kit.

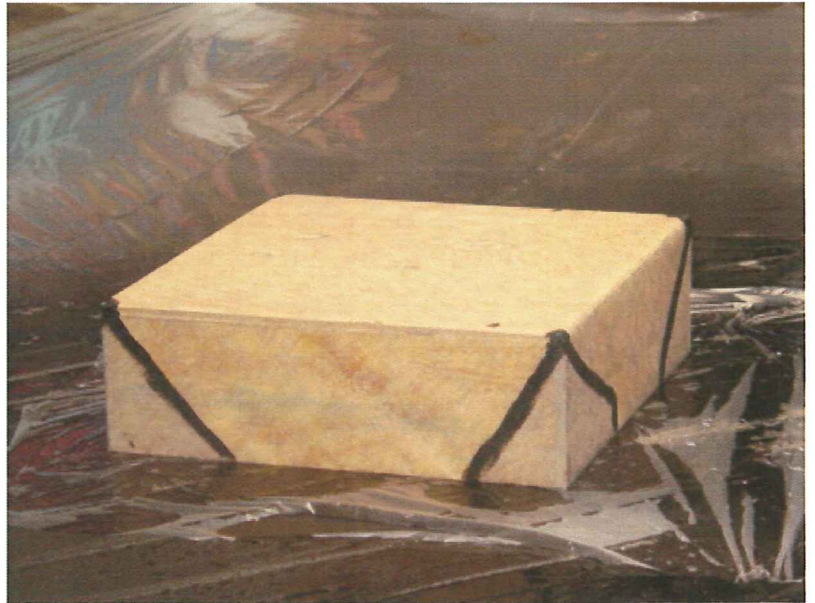
**Photo 1**

A wooden mould has been covered with a thin glass fleece in order to be able to release the Novacell afterwards.

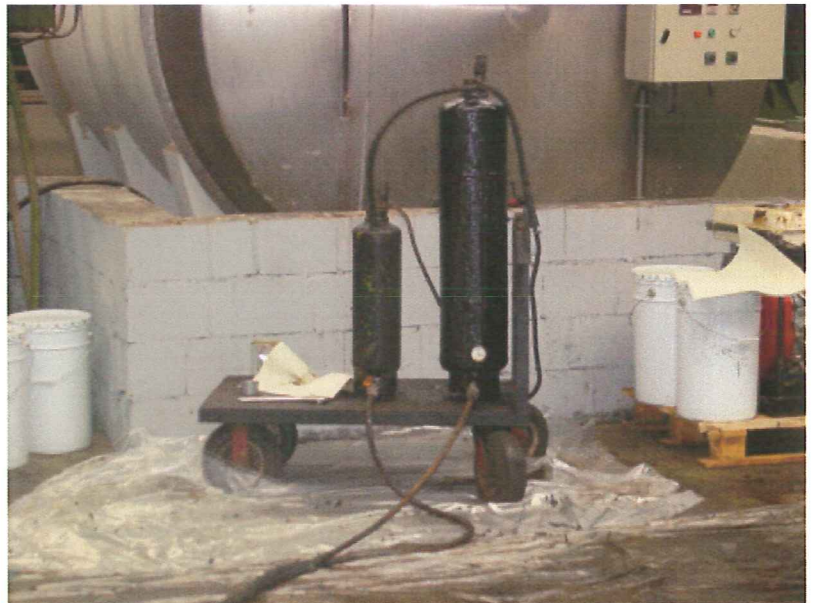
**Photo 2**

The Novacell waterproofing is produced by spraying two components together as a mixture on to a substrate.

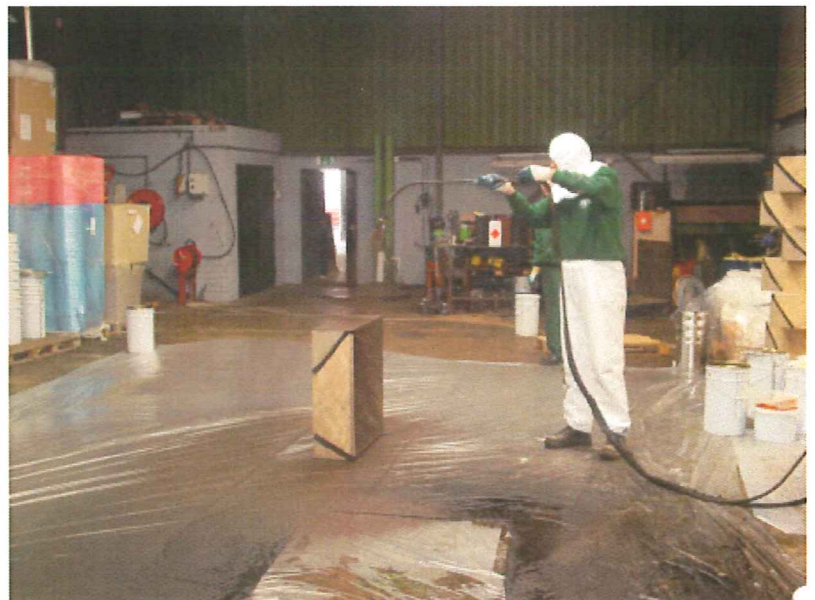
**Photo 3**

The two Novacell components are sprayed on to the mould.

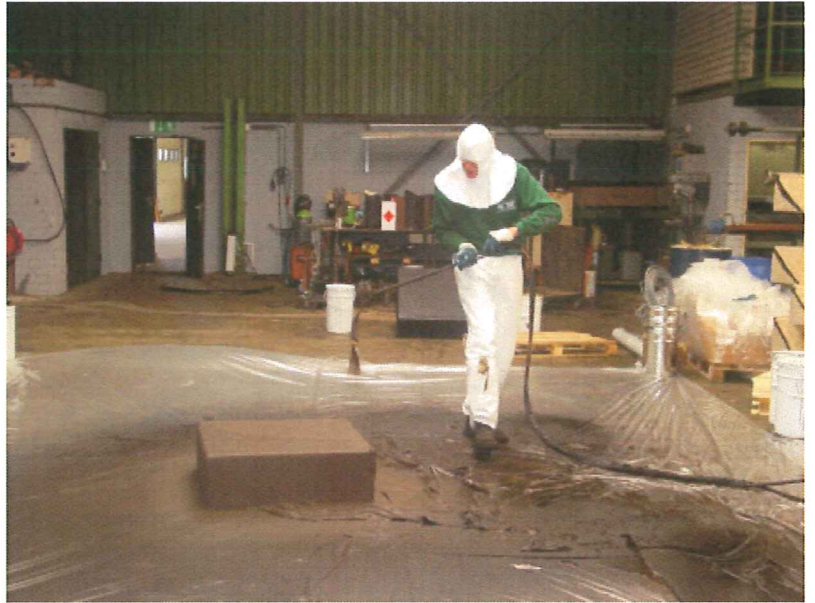
**Photo 4**

The mould is fully covered with the liquid components.

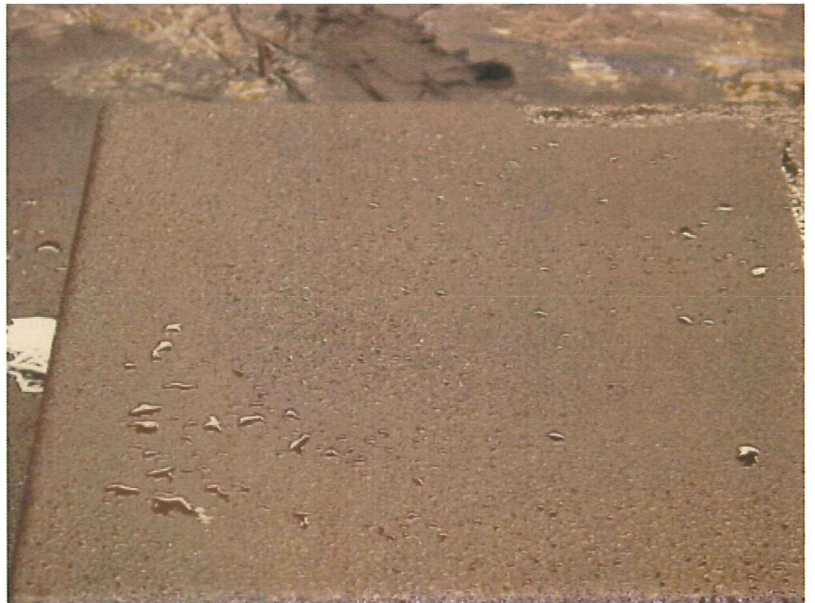
**Photo 5**

Water is secreted due to breaking of the emulsion.

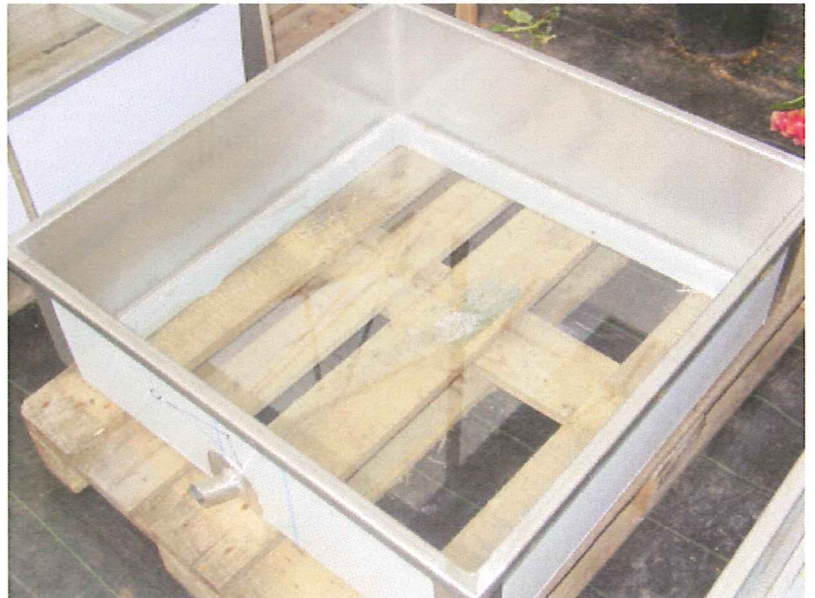
**Photo 6**

The test container with transparent base.

- \* Stainless steel container, dimensions 800 mm × 800 mm, with a transparent base (glass) to allow observation and constructed as a tray with a 20 mm rim support for constant water storage.

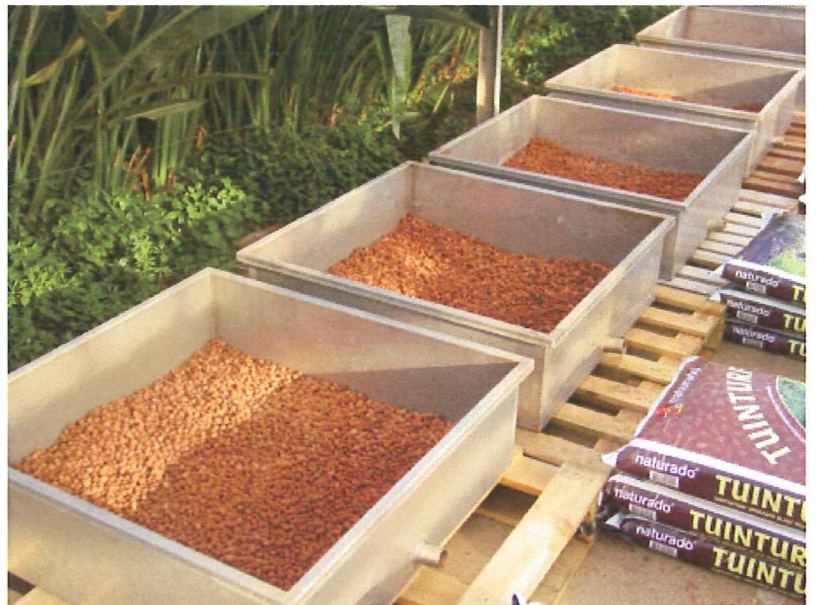
**Photo 7**  
The moisture layer is placed in the test containers.

- \* 50 mm of layer composed of expanded slate/clay (granulation 8-16 mm).

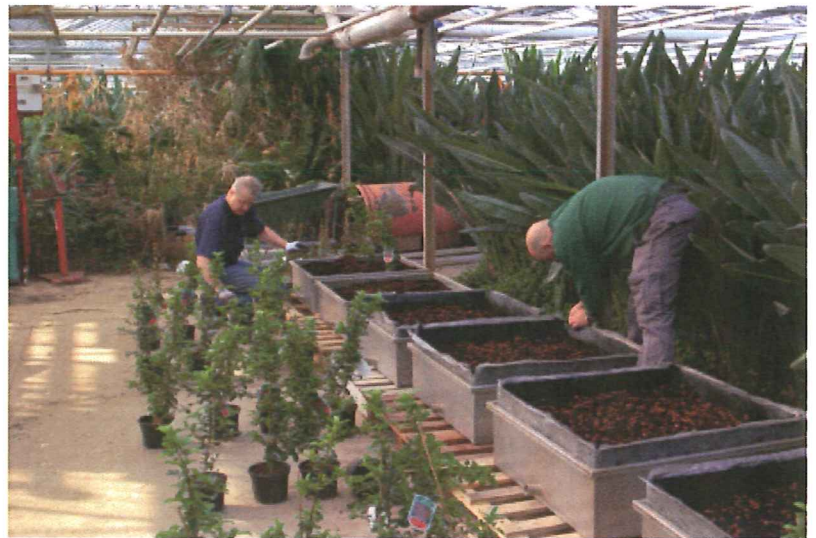
**Photo 10**  
Planting of the shrubs.

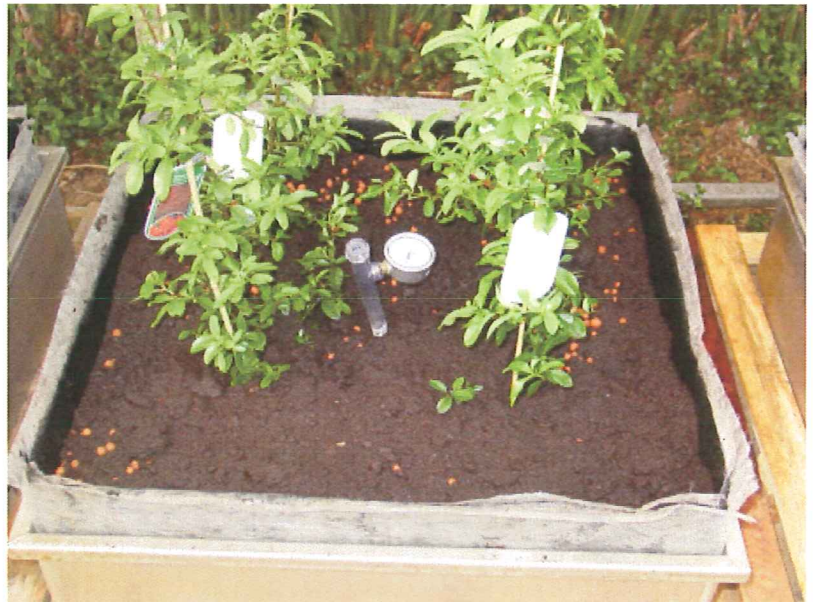
**Photo 11**  
The growing substrate and four shrubs have been placed on the test specimen.

- \* 150 mm of growing substrate with four pieces of *Pyracantha coccinea* 'Orange Charmer' (firethorn) are placed in each corner (see figure 1 in annex B).

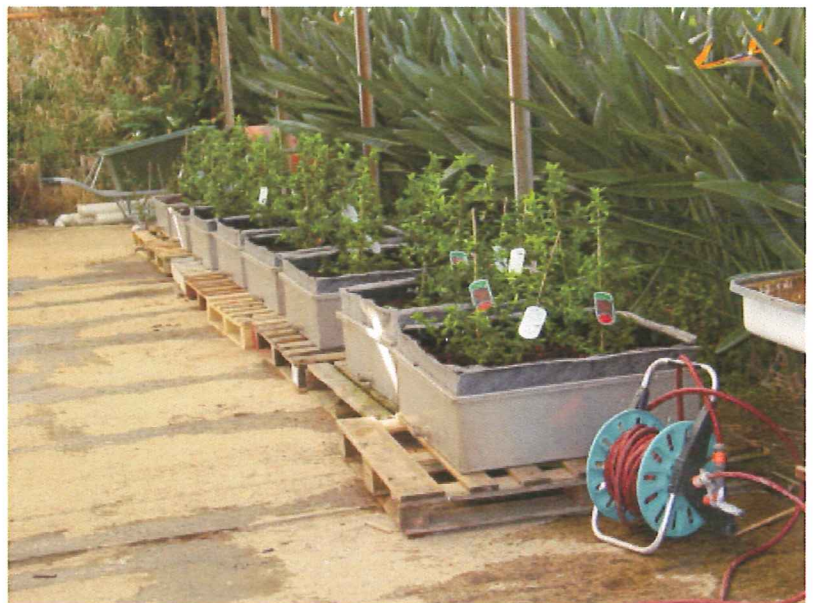
**Photo 12**  
Overview of the test containers in the greenhouse.

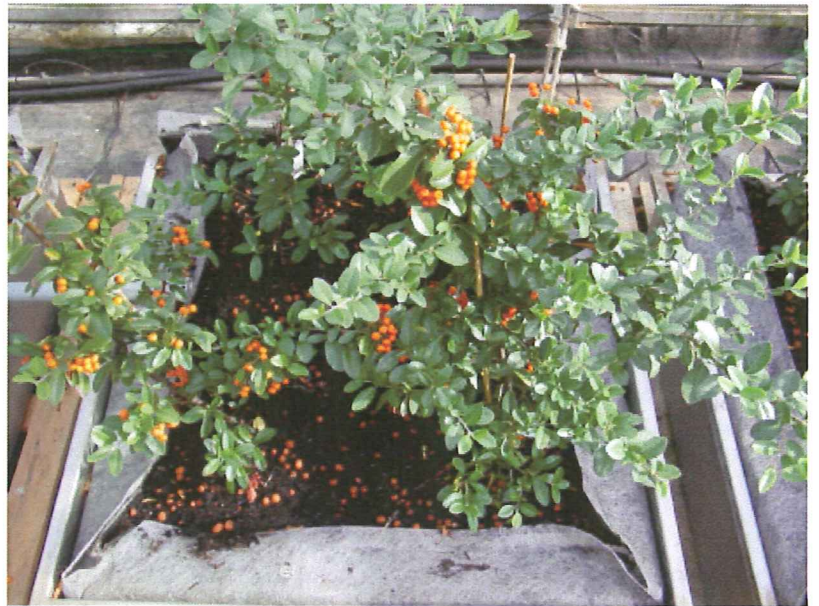
**Photo 13**  
One of the test containers after one year.

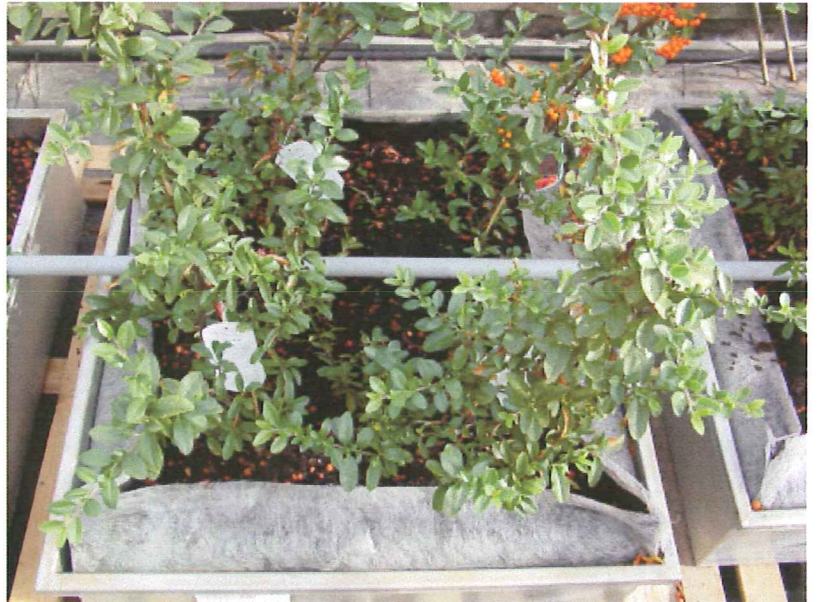
**Photo 14**  
One of the test containers after one year.

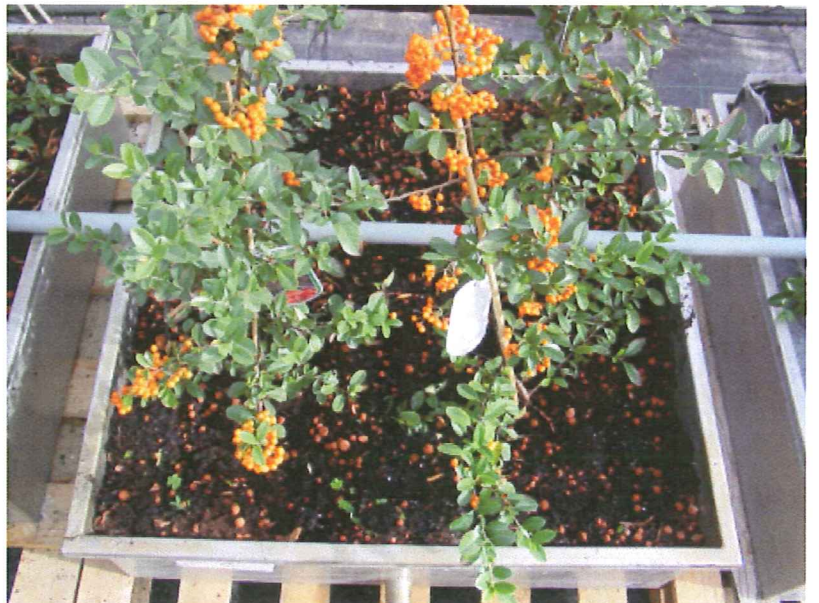
**Photo 15**  
One of the reference containers after one year.

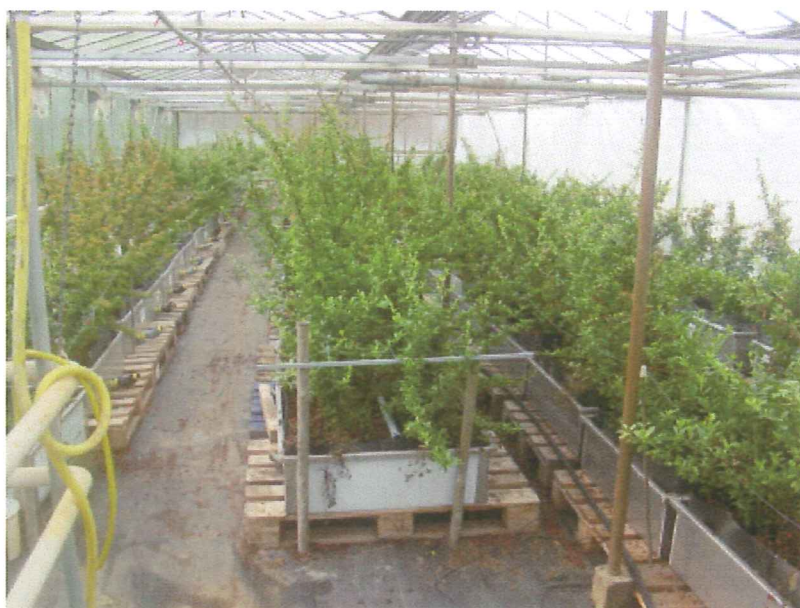
**Photo 16**  
Overview of the test containers after two years.

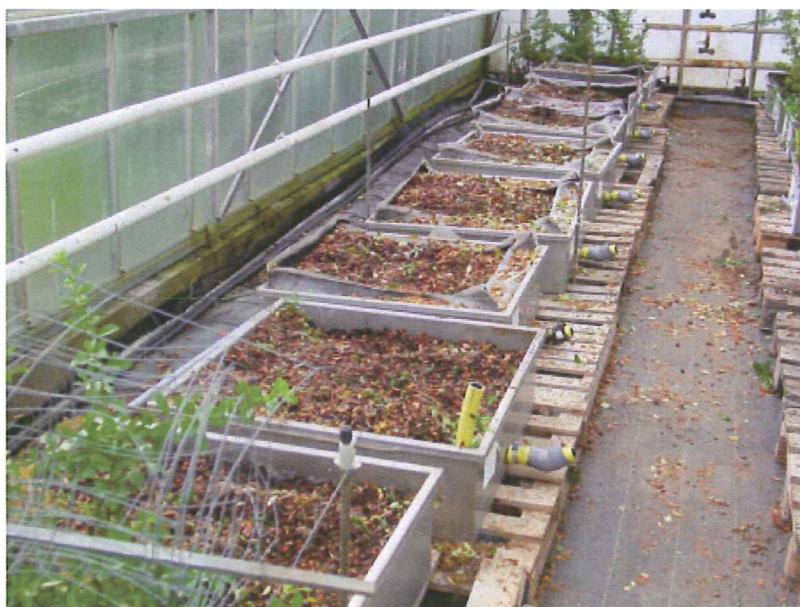
**Photo 17**  
Overview of the test containers after trimming the test plants down to the ground.

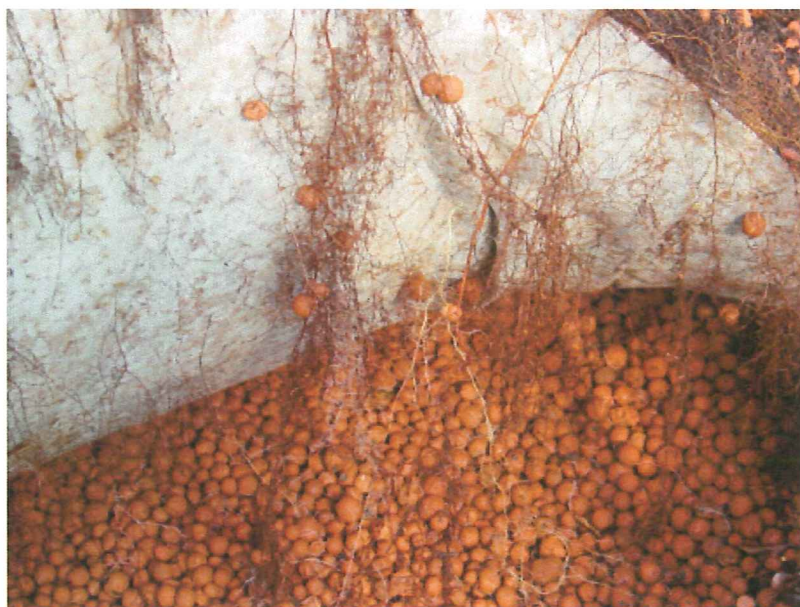
**Photo 18**  
Root perforation in one of the reference containers.

Container	Observation through the transparent base			
	6 months	12 months	18 months	24 months
Test specimens				
1	no penetration	no penetration	no penetration	no penetration
2	no penetration	no penetration	no penetration	no penetration
3	no penetration	no penetration	no penetration	no penetration
4	no penetration	no penetration	no penetration	no penetration
5	no penetration	no penetration	no penetration	no penetration
6	no penetration	no penetration	no penetration	no penetration
Reference containers				
7	no penetration	no penetration	root penetration	root penetration
8	no penetration	no penetration	root penetration	root penetration

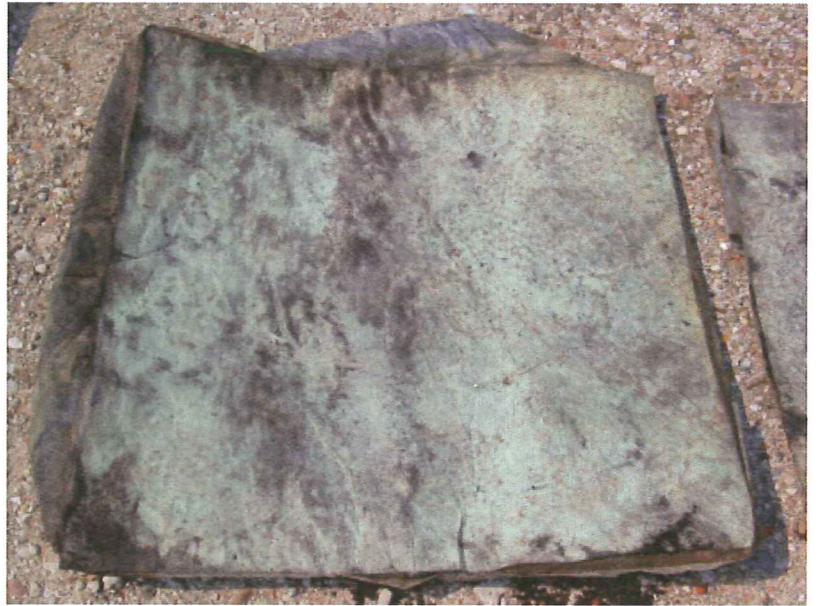
**Photo 19**  
No root penetration or perforation at the test containers.

At the end of the test none of the test specimens showed root penetration nor root perforation.

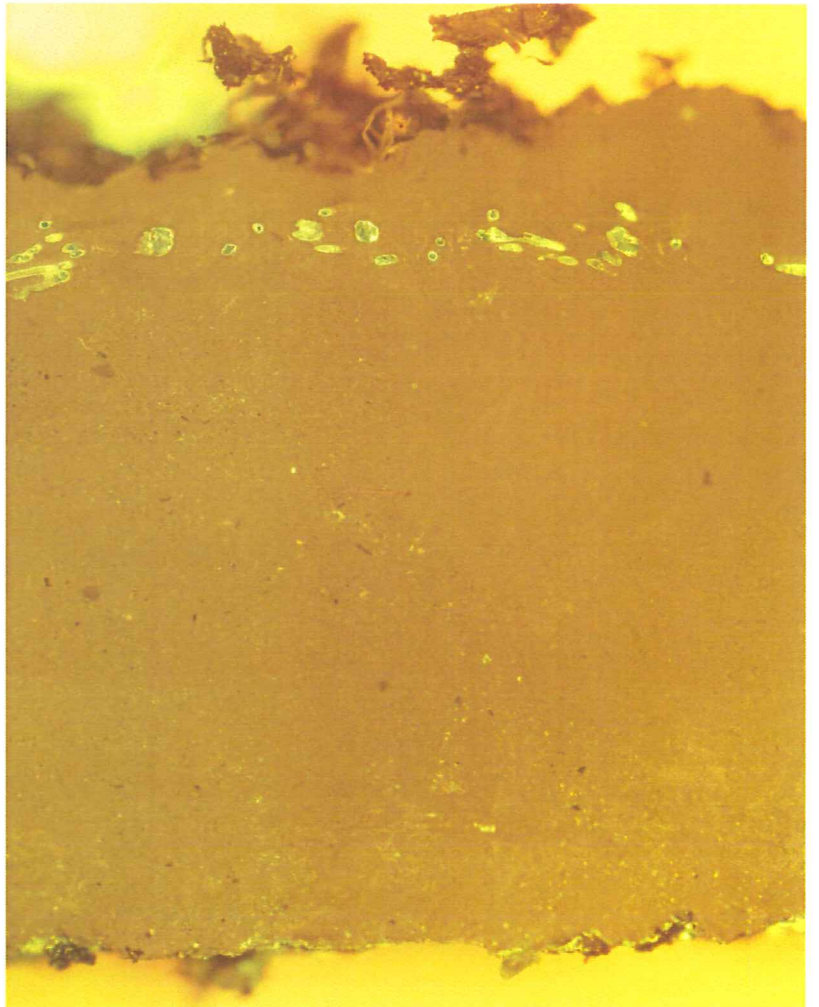
**Photo 20**  
No root penetration or perforation, judged on a cross cut by fluorescent microscopy.

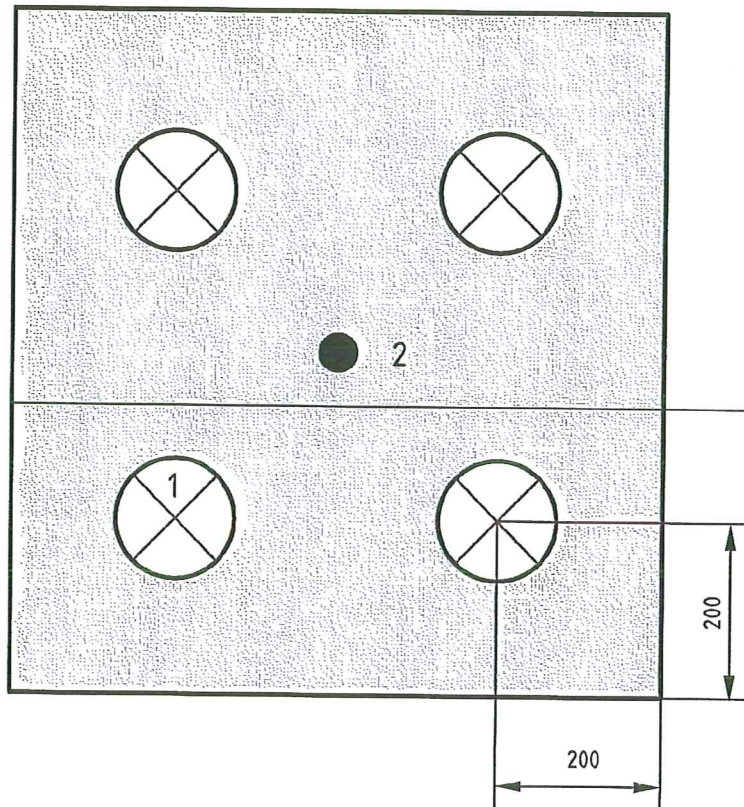
**Figure 1 – Position of the test plants and the tensiometer in the growing substrate for an 800 mm × 800 mm container**

Dimensions in millimetres
